32-Person Hot Tub Gets Lift

Written by Ty Taylor

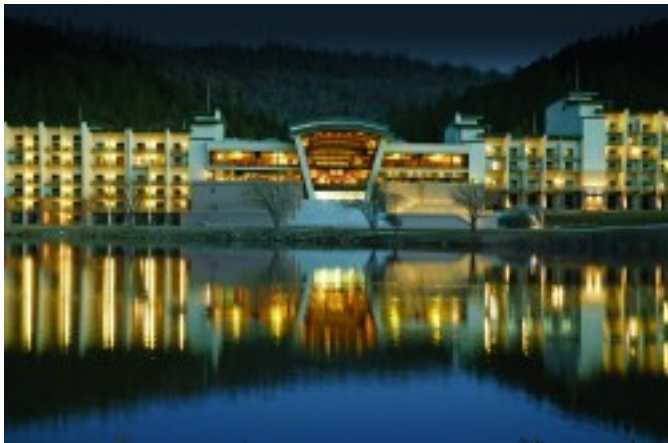
A New Mexico mountain resort recently unveiled their new fitness complex which featured a large indoor swimming pool and 32 person spa. Built on the side of a mountain, on side of the spa structure sits on top of approximately 12.0' of fill material. When the spa and portions of the deck began to show telltale signs of settlement, the spa was drained and taken out of service, and an investigation was conducted. This investigation revealed a large plumbing leak which had occurred under the pool/spa deck, causing compaction and consolidation of the supporting fill materials. The general contractor on the job broke out a section of the pool deck to make the plumbing repair, and then turned to URETEK ICR for the remediation of the settlement issues.

URETEK ICR proposed a comprehensive solution using [The URETEK Method®](#) to void fill under the deck and lift it back to its proper position, and utilization of the [URETEK Deep Injection® Process](#) to inject at depth under the spa for void filling and stabilization.

Upon acceptance of the proposal by the general contractor (and a change order to do additional areas), URETEK mobilized at the job site. Void filling beneath the deck was accomplished first, along with lifting of the deck where needed.

URETEK then turned their attention to solving the deeper problems, with utilization of the patented URETEK Deep Injection® Process. Soil borings indicated voids were present at depth of nearly 11.0', surrounded by soft soils, so technicians drilled to that level, then inserted copper

tubing to the same depth. As URETEK 486 material was injected, it rapidly expanded filling voids and, always following the “path of least resistance,” fractured and squeezed the loose soils. This process was continued until resistance of the soil was detected at the surface, by a “bump” on the laser detector, insuring that the soils were sufficiently densified to support the load of the water filled spa.

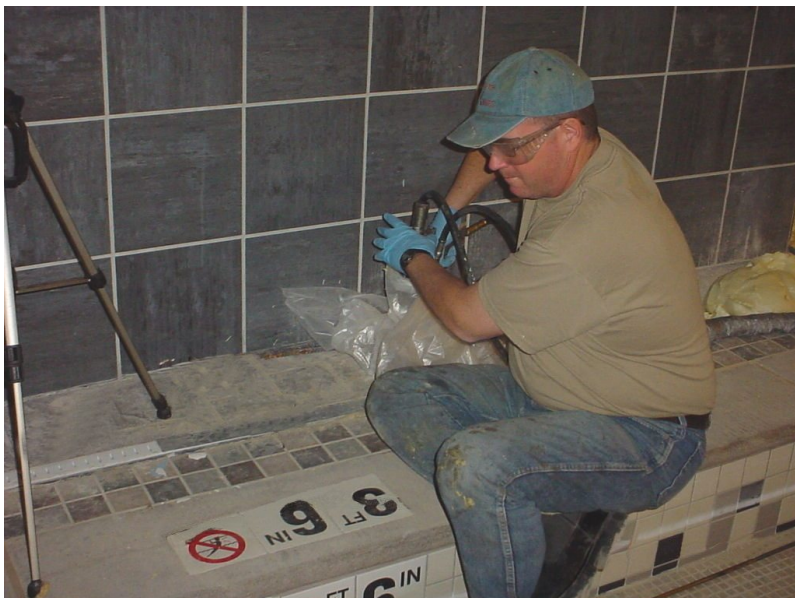
URETEK ICR representative Scott Turnage traveled to the resort in order to assess the evidence of settlement, review the forensic geotechnical report, and determine the approximate size of the voids under the deck. This examination revealed that an approximately 1,200 square foot portion of the deck had settled up to 1.0", resulting in concrete cracks and gaps below the walls, with voids of up to 24.0" under certain portions of the stamped, concrete surface. The spa structure itself has also settled, evidenced by cracking in the sidewalls, below the coping.
